# NDB Bearing Errors

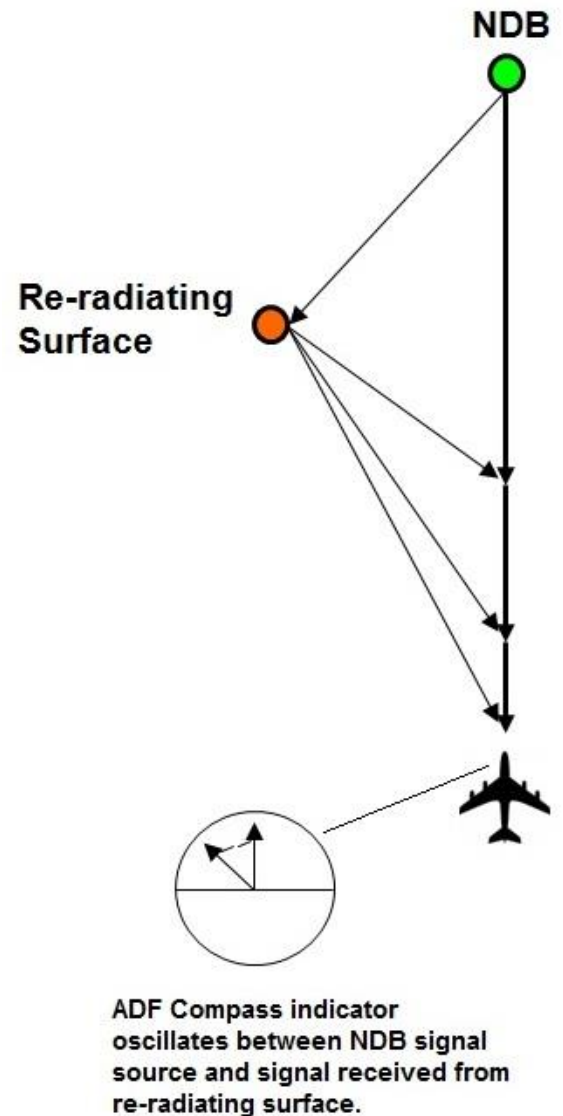
Remedial measures may be possible in multipath conditions. Single tower re-radiators can sometimes be detuned at the operating carrier frequency by the installation of radio-frequency chokes. This would not of course be possible where re-radiation results from natural topographic features such as metallic ore deposits in mountainous terrain. Because the efficiency of a re-radiator often varies with frequency, the problem can sometimes be resolved by changing the operating carrier frequency. Where a commonly used approach direction is involved, it is sometimes possible to improve system performance by re-locating the NDB. A low power, portable NDB and antenna can be used to seek a more suitable location or operating frequency. Moving the NDB closer to the re-radiating structure such that the re-radiated signal emanates from the same location may be a possible solution.
